Occupational Fatality Report

Municipal Electrician Dies after Falling out of an Aerial Lift Truck's Raised Bucket after It Was Struck by a Semi-Tractor Trailer – Massachusetts

Release Date: April 15, 2014
Investigation: # 12-MA-013-01

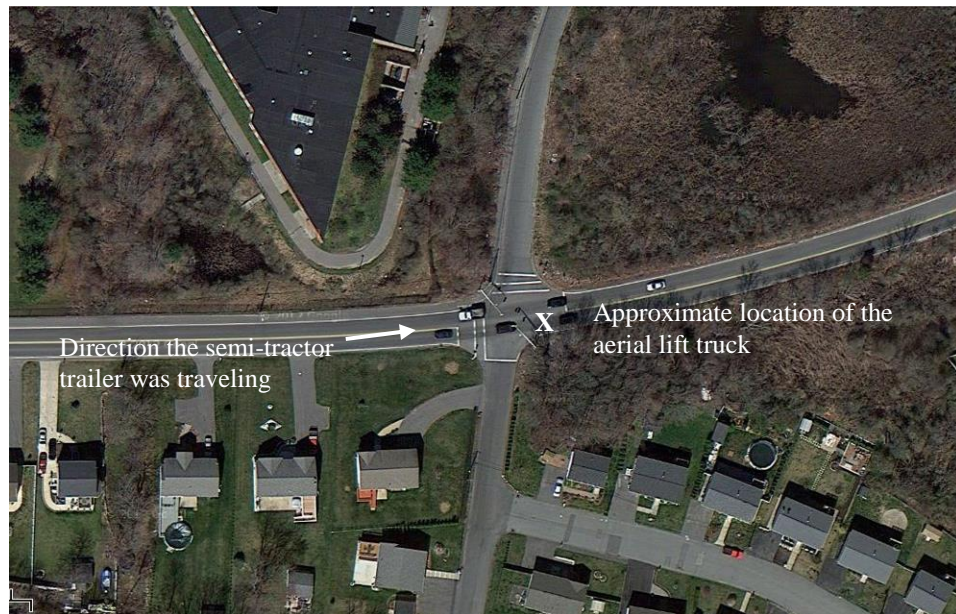
The incident occurred at a four-way intersection located in a primarily residential section of the city. The intersection is made up of a main roadway and side street that crosses the main roadway (Figure 1). The area around the intersection has no significant grade, is relatively straight and is designated as a 30 mile-per-hour speed zone. The main roadway has one travel lane for each direction. The primary travel direction of the main roadway is north and south, but at the incident location the roadway runs east and west. There are multiple painted roadway markings in the area. The main roadway's two travel lanes are separated by solid double yellow painted lines and there are painted fog lines at the main roadway edges. The side street runs north and south and does not have many roadway markings. At the intersection, each travel lane has painted white traffic stop lines and there are two crosswalks; one across the main roadway and one across the side street. The incident location is a heavily traveled area with houses on the south side of the intersection and a school and an undeveloped lot on the north side.

Figure 1 – Aerial view of the intersection

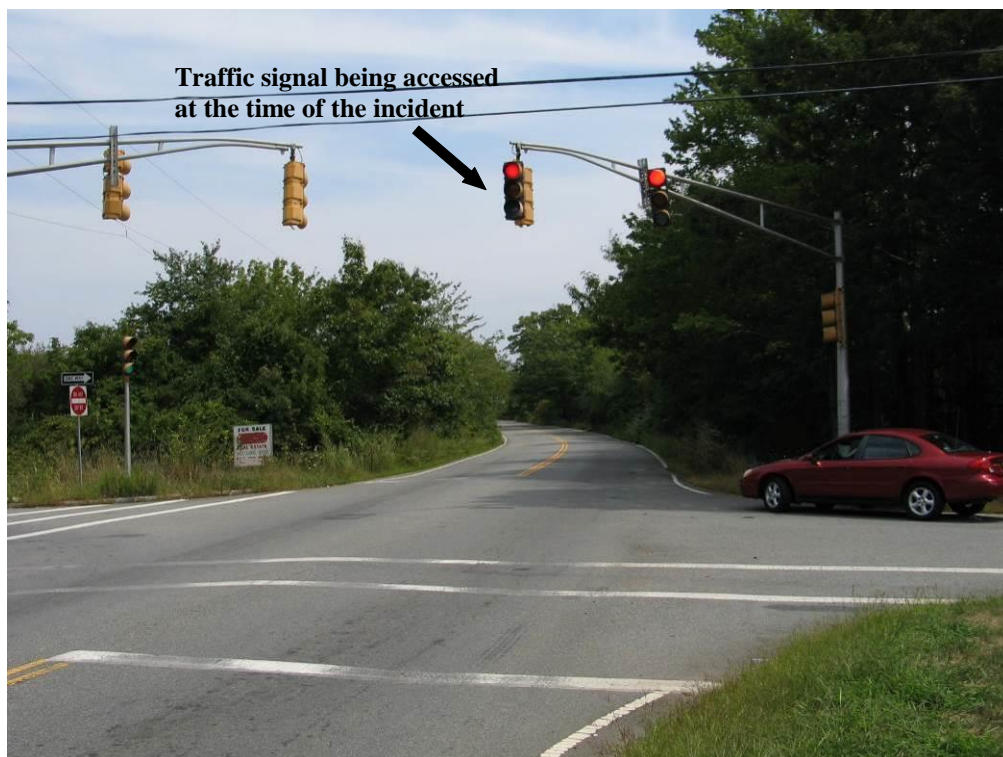
The intersection has two cantilevered traffic signal structures, one of which was being accessed at the time of the incident. The base of the cantilevered structure that was being accessed is located beyond the shoulder of the roadway on a grassy area. The vertical pole section of the base reaches a height of approximately 18 feet (Figure 2). The cantilevered section is fastened to the top of the vertical pole and extends out over the eastbound lane of the main roadway. The end of the cantilevered section over the intersection has two traffic signals attached. The distance between the bottom of these traffic signals and the roadway below is 15 feet seven inches. At the time of the incident the traffic signals were operating on a regular cycle.

Figure 2 – Street view of the intersection looking east on the main roadway

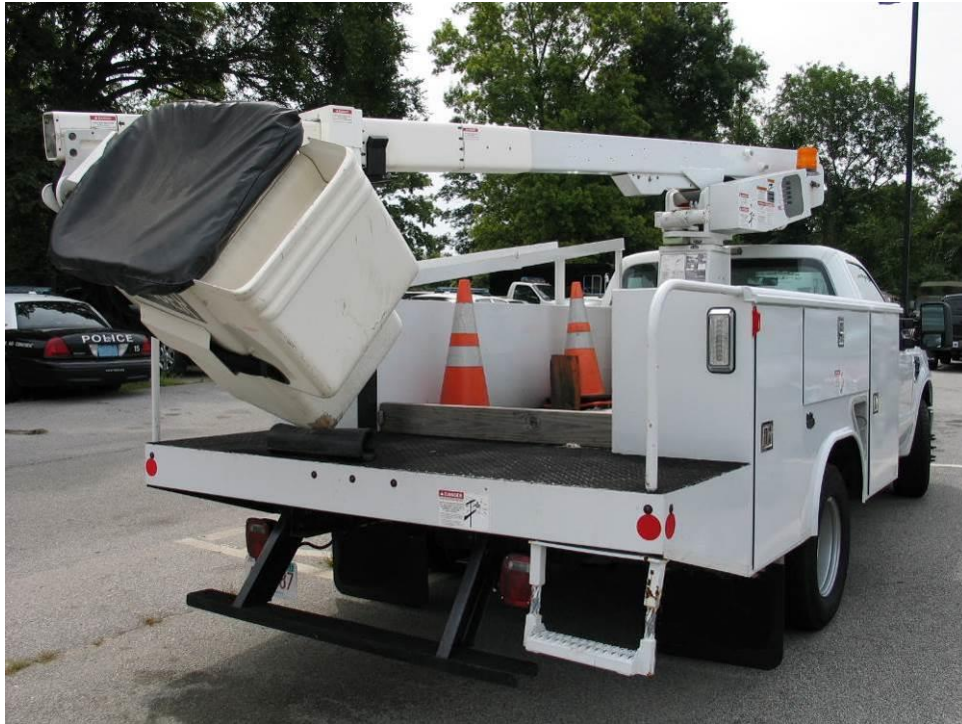
The aerial lift truck's chassis and aerial lift body were both manufactured in 2009 and were white in color (Figure 3). The truck was equipped with dual rear wheels and had a gross vehicle weight rating of 5,897 pounds. The truck's telescoping and articulating boom platform had a height rating of 35 feet. There were two sets of controls for the movement of the truck's boom/bucket. One control was mounted to the bucket itself and the other control was mounted on the truck's body at the ground level along with an emergency stop. The vehicle was equipped with blue light-emitting-diode (LED) strobe lights located at the front and rear of the truck and two rotating orange beacon lights at the base of the boom. There was a fall protection anchor point located at the truck's bucket along with a danger decal warning of the fall hazard and the need to use fall protection (Figure 4). A body harness and lanyard were stored in the aerial lift truck.

Figure 3 – Aerial lift truck involved in the incident

Recommendation #8: Manufacturers of aerial lifts and employers should consider using contrasting colors and installing strobe lights along the booms of aerial lifts.

Aerial lift trucks are often used in and around roadways, which can place the truck in close proximity to moving vehicles. To help make aerial lift trucks, including their booms and buckets, as visible as possible, consideration should be given to adding contrasting colors, which could also be florescent and/or reflective, to both the boom, bucket and to some areas of the truck. In addition, adding some light-emitting-diode (LED) strobe lights to sections of the boom, bucket and truck might increase both the visibility of the truck and the actual location of workers when they are working from the truck's raised bucket.

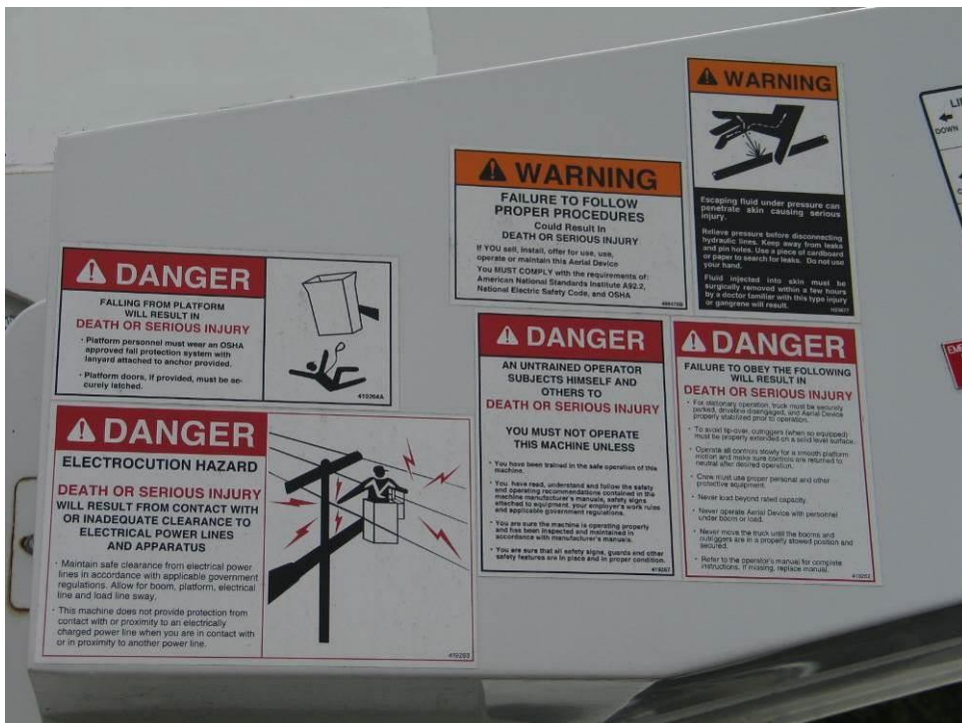
Figure 4 – Aerial lift truck's danger decals

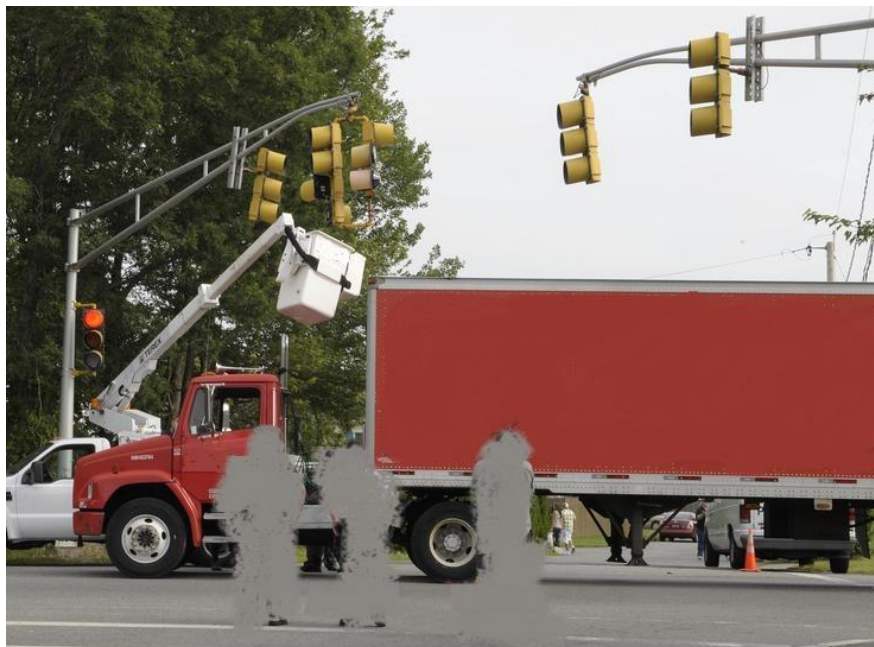
As the victim was working on the traffic signal a semi-tractor trailer was traveling east on the main roadway in the eastbound lane approaching the intersection and had a green traffic light at the intersection. According to the police report, the tractor trailer driver reported that he noticed the aerial lift truck parked on the side of the roadway, but did not notice the raised bucket. The tractor trailer driver veered to the left of the roadway's center line to keep away from the parked truck. As the tractor trailer entered the intersection the cab passed underneath and cleared the raised bucket. When the semi's trailer section reached the raised bucket, the trailer impacted the bucket causing the bucket to bounce up. The victim was ejected out of the bucket and fell approximately 16 feet to the asphalt roadway below.

Figure 5 – Incident location after the incident showing the traffic signal, the aerial lift's raised buck and the semi-tractor trailer
